Site Report	GEOTECHNICAL ASSESSMENT - ASHBURTON
-------------	-------------------------------------

Client	Rooney Holdings Ltd
--------	---------------------

Address	Tarbottons Road / cnr Nixon Street - ASHBURTON
---------	--

Contract Number	238042 / 37
-----------------	-------------

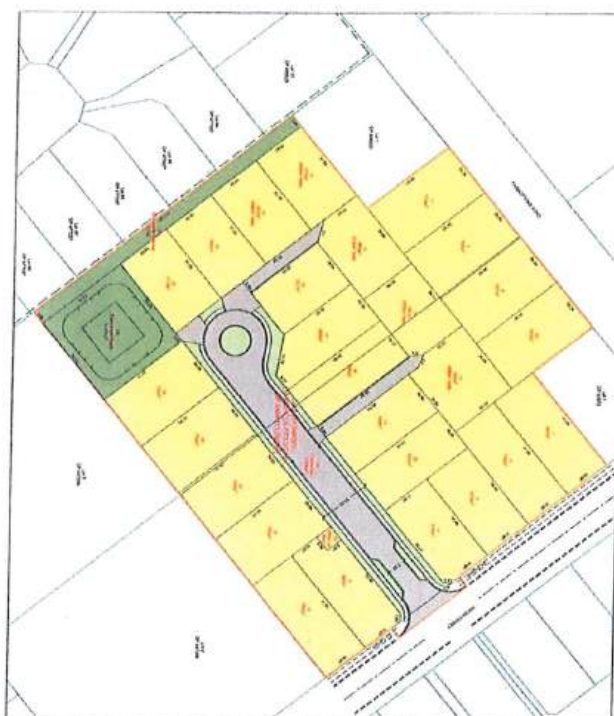
Figure 1. Subdivision to investigate

The address is zoned as a *Medium Density Residential Zone* classified as *Residential C*. The purpose of this zone is to maintain residential areas with open space for trees and garden plantings and with minimal adverse effects experienced by residents. The site-property has a reasonable flat contour, currently accessed from the North-West via Tarbottons Road and from the North-East via Nixon Road comprising 27 lot sections ranging from 537 to 710 metres square (*Figure 1*). On the South-Western boundary Carters Creek flows from North-West to South-East. Both sides of the creek banks well protected and fenced.

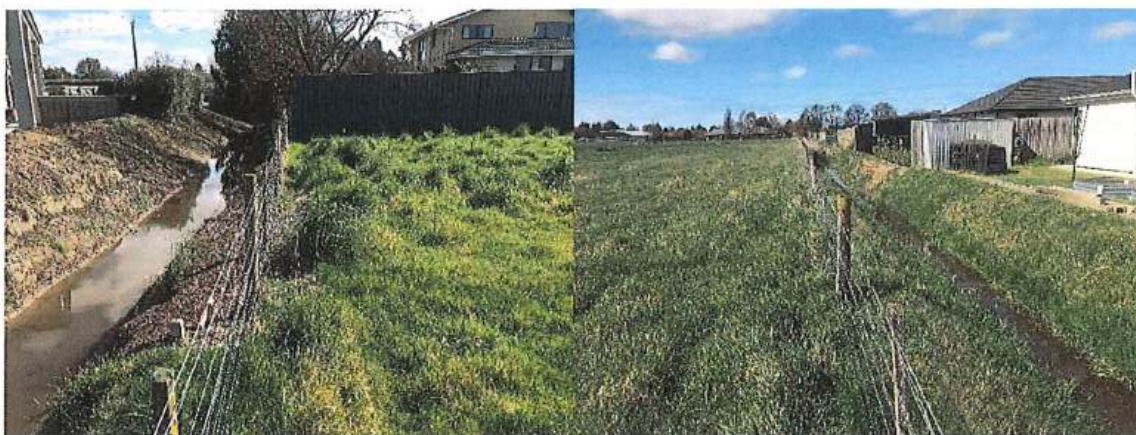
Figure 4 & 5 Carters Creek full view

The nearest surface water body to the site is Carters Creek (*Figures 4 & 5*), a small stream located along the western boundary of the site. The nearest major water body is the Ashburton River, which is located approximately 700m north-east of the site. Environment Canterbury database show a number of eight bores at a radius of 250m from the site, four of these bores are active. The bore search indicates water table is expected to be present at a depth of 2-3m below ground level.

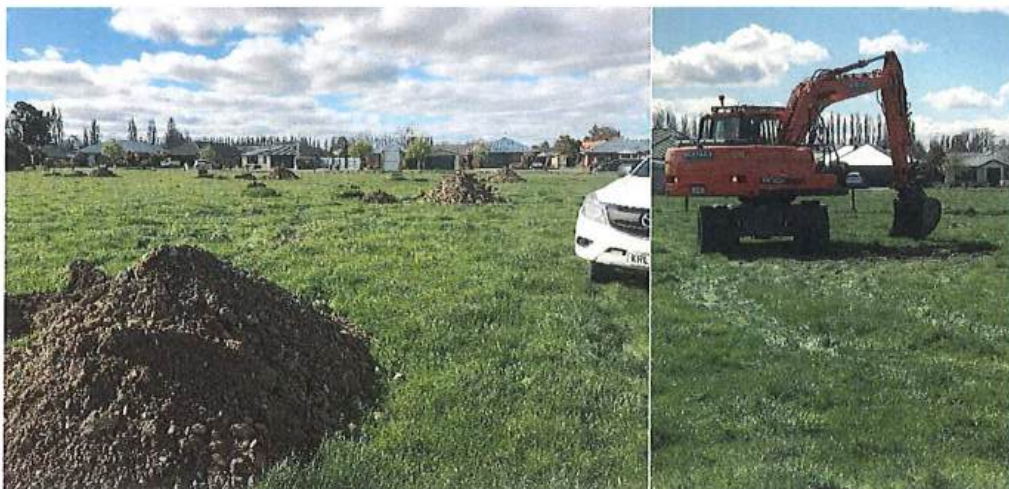
Figure 6 Partial view of site testing

A total of 27 lots were tested for two days. The site was plotted with pegs, marking a centre point within the area of each lot section. A 14Ton wheel digger and operator was supplied by the client to ease the excavation process which we aimed to inspect at depths of 2.5-3.0m. Health & Safety measures were also considered to ensure everyone did not come too close to excavations pit, as these were left opened once we reached water table and waited until water level stabilised before being measured.

Figure 7 Excavator used for test pit sampling

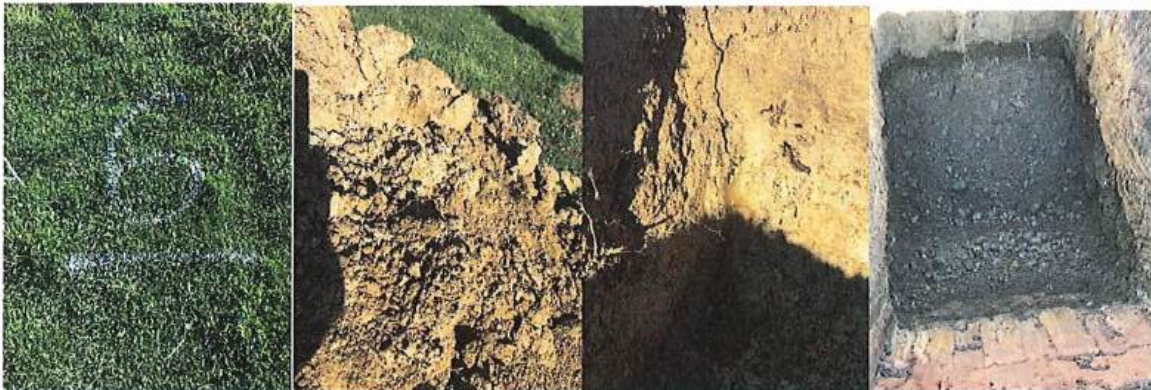
Photos lot 6

Only one section appeared with larger tree roots at depths of 1.5m-1.7m from NGL. This belonged to Lot 6, and at the excavation these appeared from South and South-West respectively at the granular soil strata.
